## STRUCTURAL EVALUATION OF AN ADVANCED COMPOSITE HYDROFOIL FOIL COMPONENT

TEST AND EVALUATION REPORT

REPORT DOCUMENTATION PAGE		READ INSTRUCTIONS BEFORE COMPLETING FORM
1. REPORT NUMBER <b>DTNSRDC-82/082</b>	2. GOVT ACCESSION NO. <b>AD-A122165</b>	3. RECIPIENT'S CATALOG NUMBER

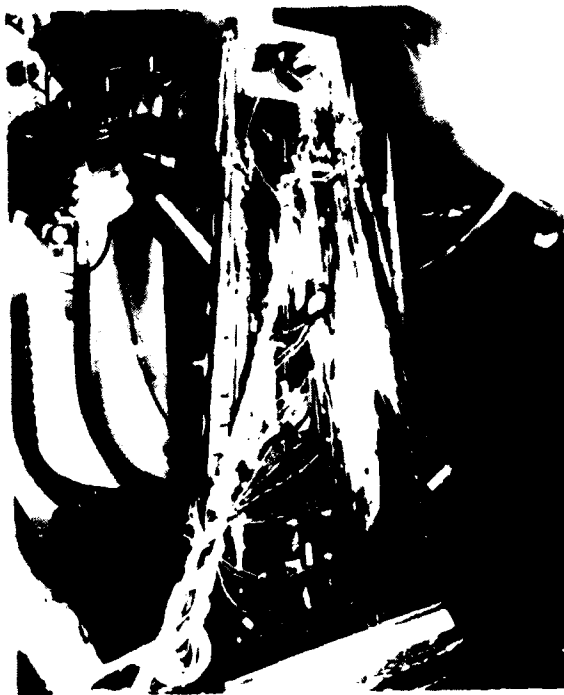
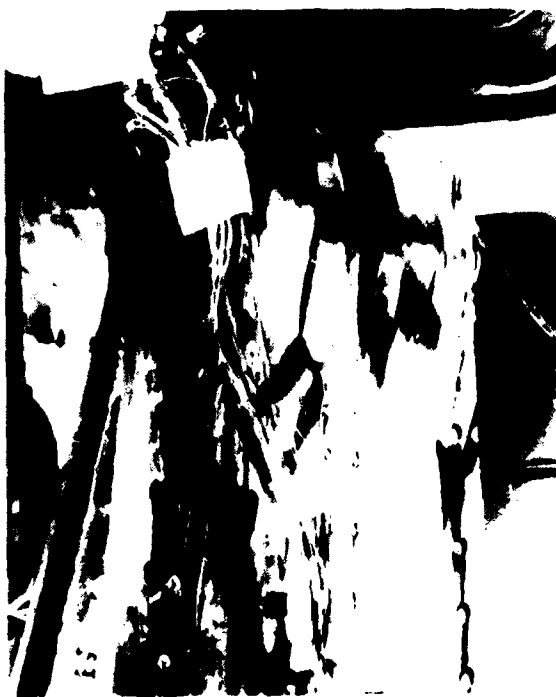
Figure 24 - Box Beam 2 After Catastrophic Failure

shut down. A static test in which deflections were measured was conducted; the results are given in Table 7. The cyclic test was resumed, and the box beam failed catastrophically after 920,000 cycles. Figure 24 shows the failed box beam.

6. Box Beam 2 delaminated in the load plate region during fatigue testing, apparently as a result of an overload caused by an electrical storm and subsequent power surge.
